## REPORTE DE INCIDENTE

### Datos Generales de Viaje

Fecha de Salida	20/2/2024	W/O	
Fecha de incidente		Cliente	Hapag Lloyd
Fecha de Ingreso	29/2/2024	Nº Contenedor	
Nº EIR	170538	Ruta

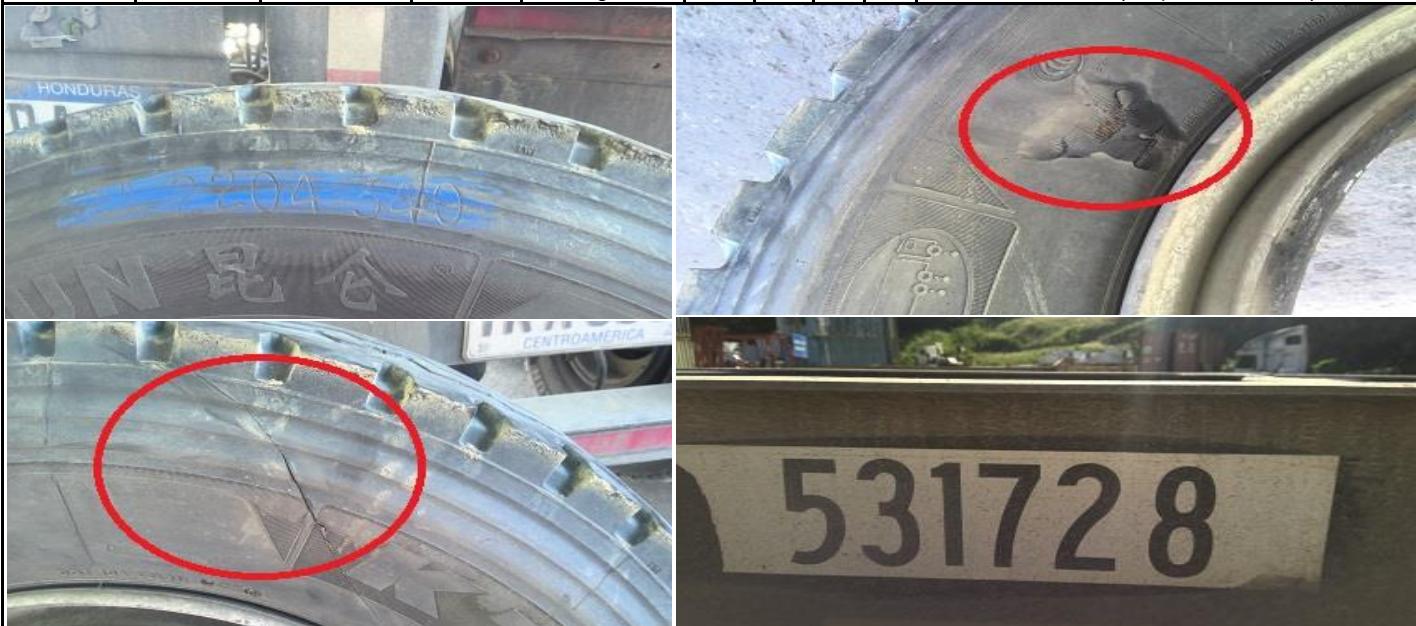
Llanta Nº	Tamaño	Marca	Diseño	Orig./Reenc.	Lonas	Dot	MM	Pos.	Causa del Retiro
EXA2204340	11R22.5	KUN LUN	kt865	Original	16	4621	9	1	Estallada (Golpe En Costado)

Llanta posicion 1 estallada por costado , llanta presenta golpe en costado falla operativa
