S U R V E Y - R E P O R T H O-220.007

CONTAINER Nº:	1 X 45' HC Container Nº KOSU 451334-0 ORIGINAL SEAL # UNKNOWN
CARGO:	Junker products; car exteriors, doors, engines, spare parts, radiators, all used, in bulk.
BILL OF LADING Nº:	PEVHON 21540
MARINE TRANSPORT:	PARADERO / 20128
TRANSSHIPPED TO:	N/A
PORT OF LOADING:	MIAMI
PORT OF DISCHARGE:	PUERTO CORTES
PLACE OF DELIVERY:	YONKER RECONCO, CIUDAD COMAYAGUA, HONDURAS
SHIPPER:	NOT AVAILABLE
INVOICE:	NOT AVAILABLE

SURVEY OBJECTIVE: 1- Verify accident site and possible transshipment of container KOSU-451334-0.
2- Verify cargo condition at consignee's warehouse during unloading of the container

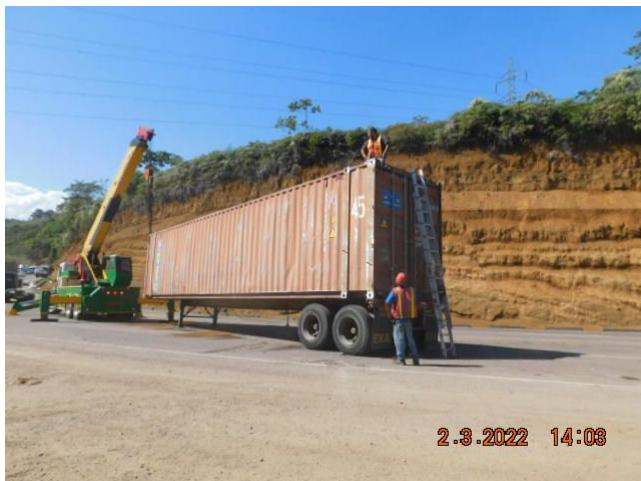
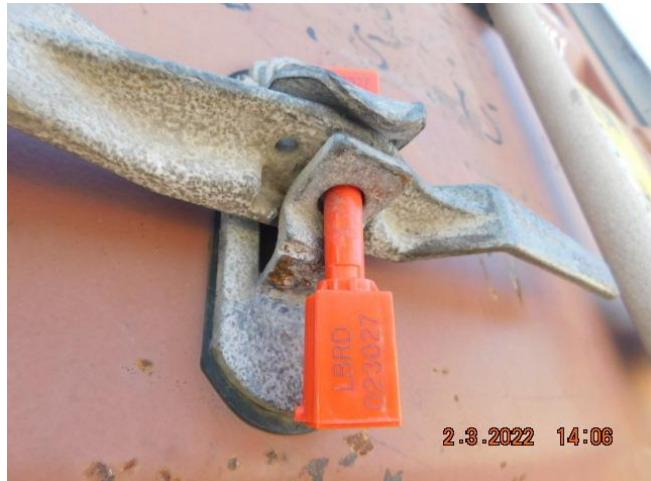
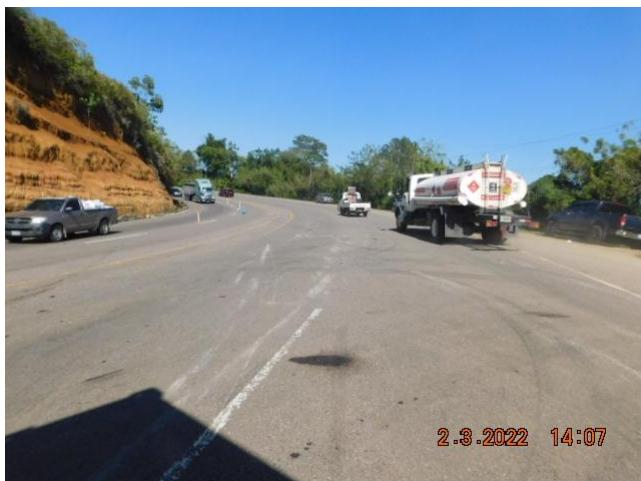
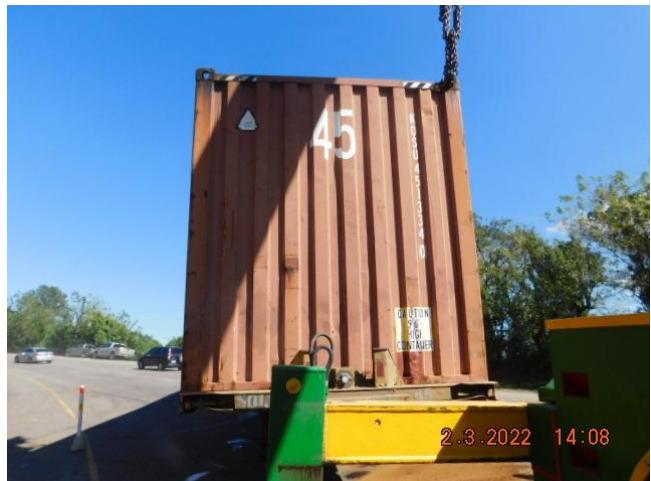
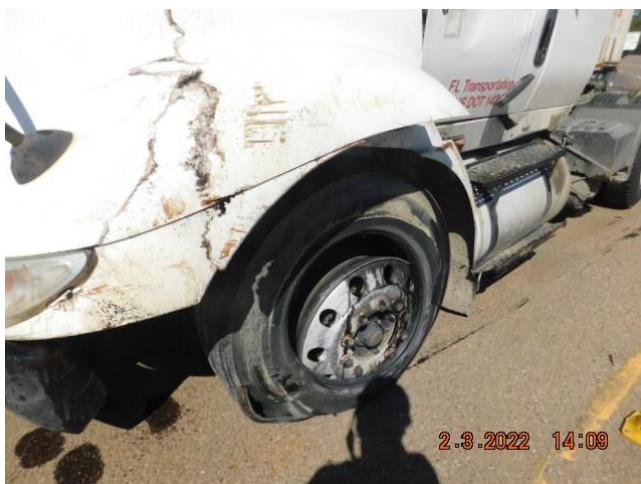
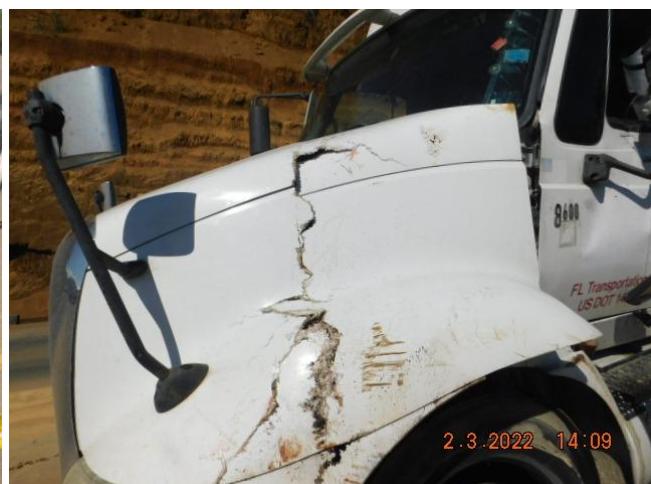
February 3, 2022

We were called to perform a survey of the situation with the container since it would be lifted and possible have transshipment of cargo to another container. We arrived to the scene of the accident at 14:15 hours and found the container had already been lifted with cranes. The container was duly sealed but was already dripping oil and water through small holes on the wall, caused by the accident.

We inspected the container for the damages sustained finding it had the paint surface of the left wall scratched and tiny holes on the wall where oil was already dripping. (Please see attached photos)

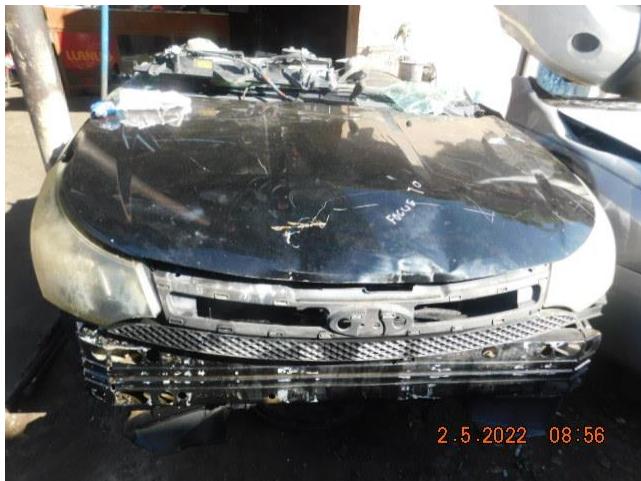
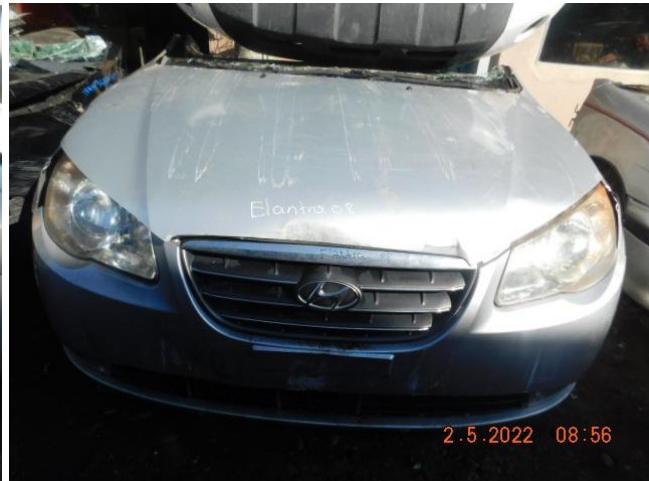
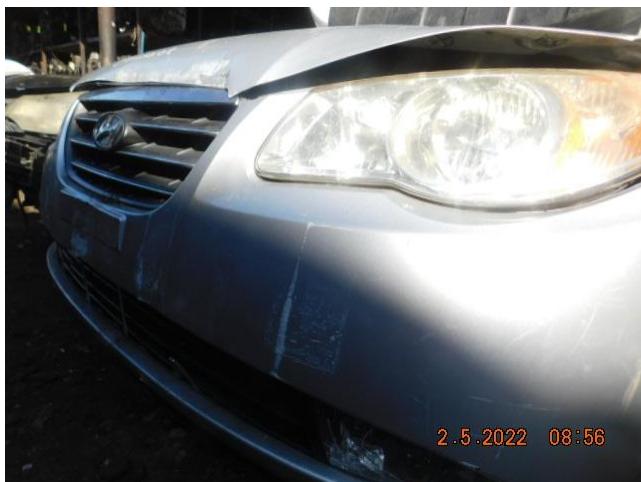
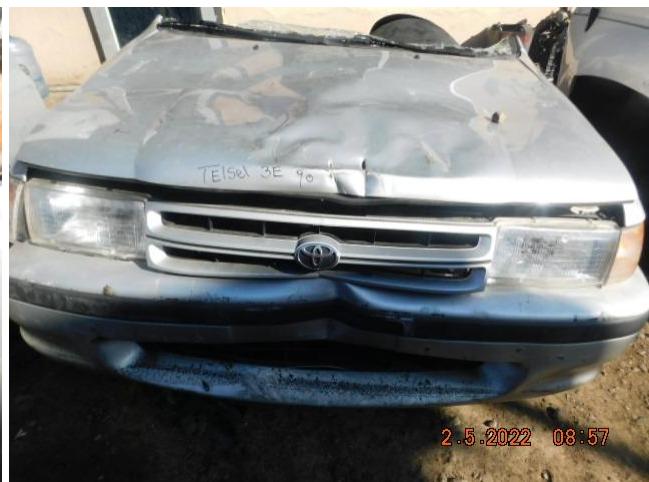
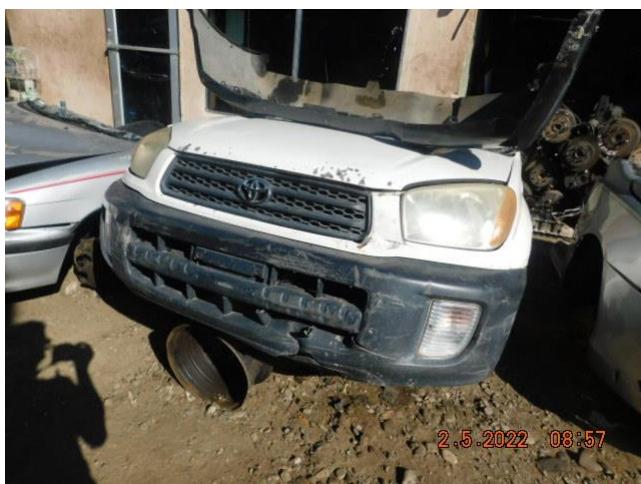
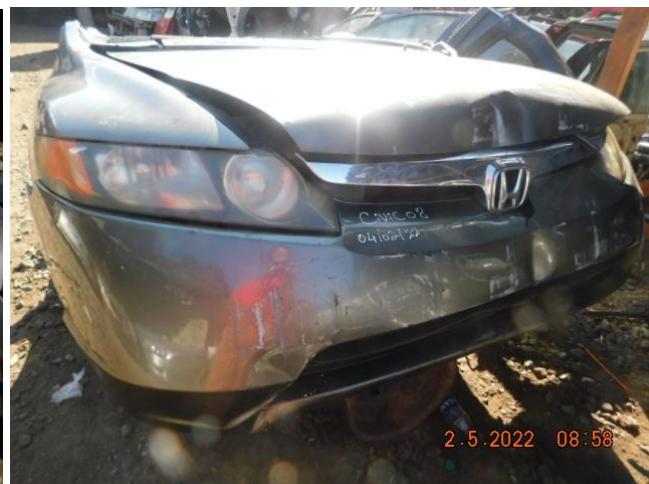
February 5, 2022

These car sections were found bumped and scratched on the front due to the impact with the wall of the container when it overturned. The engines were in apparent good condition since these are turned on but we did not witness that process since it was not done.

The vehicle sections and doors were bumped but these are not intended for reconstruction and only cover the engine. It may lower the value of the section since this are sold as found and will not be repaired.

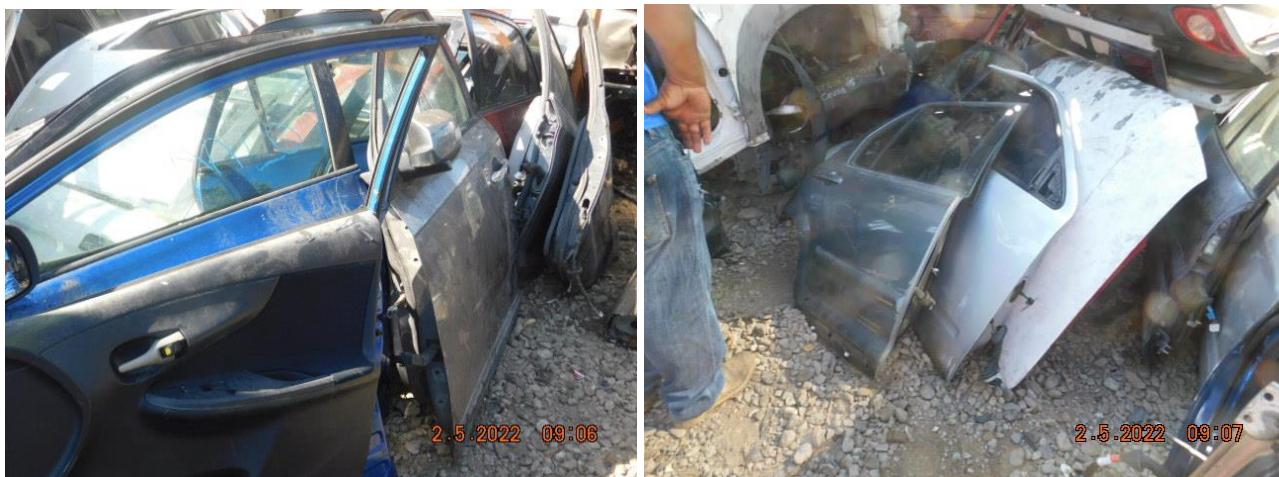
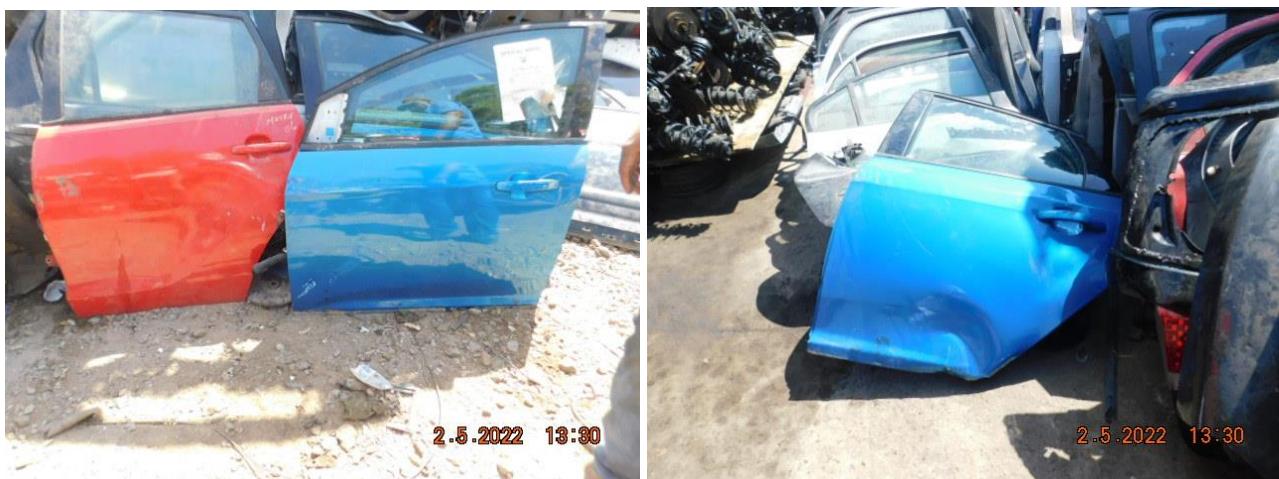
Doors

We then inspected 13 car doors that were already unloaded and had bumps and, in some cases, broken windows.

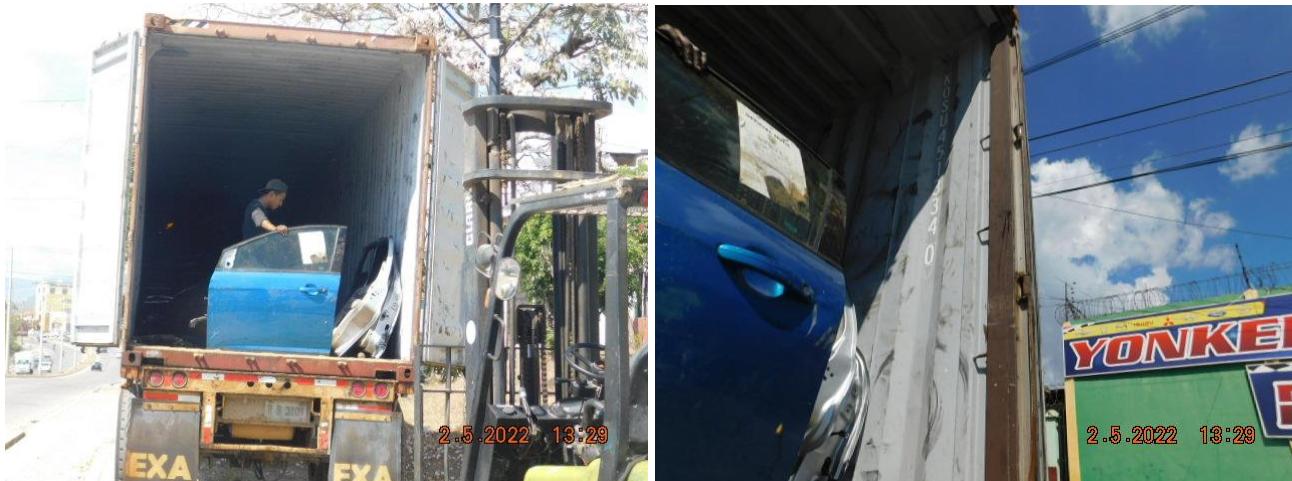
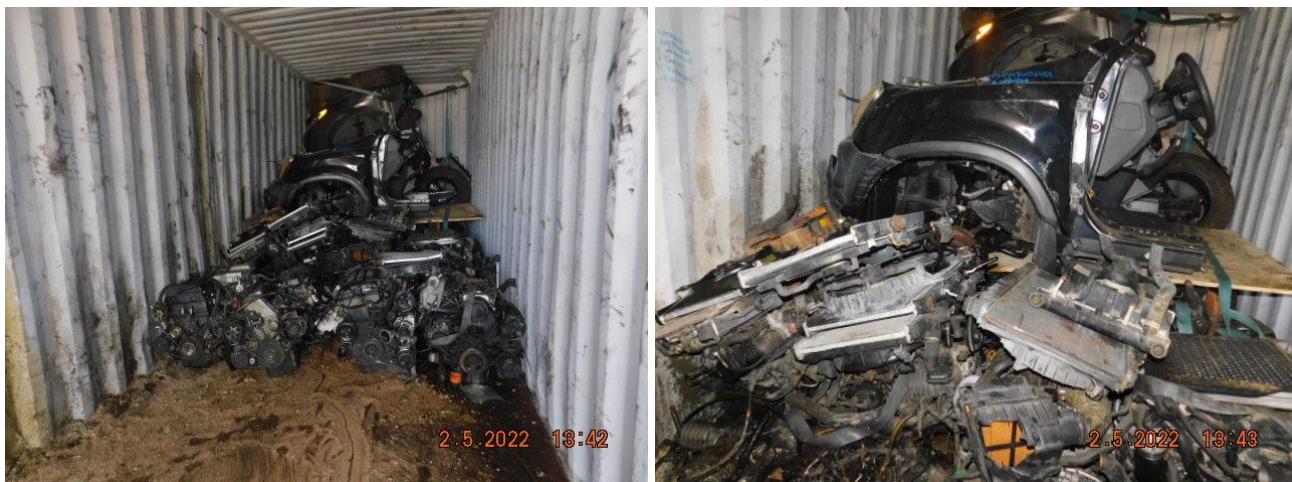
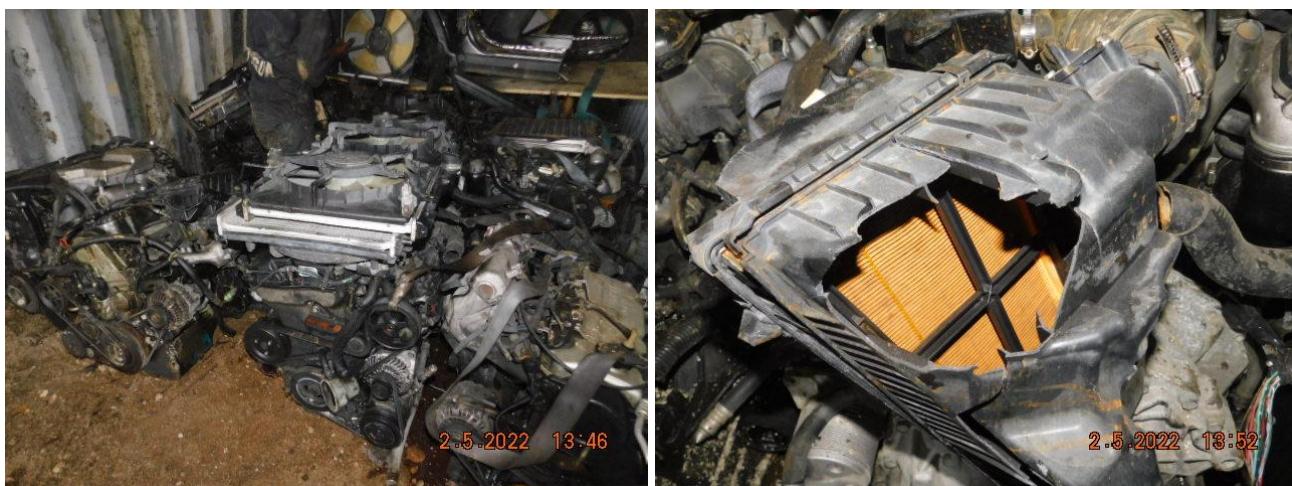
Unloading engines

As the engines were unloaded, 2 by 2, we noted some had cracked covers in the alternator and other exposed sections. We think this may be caused by the accident although the broken pieces were not found.

Some engines had cracked covers that were caused by the accident. The major concern for the engines is that oil sipped into parts it shouldn't and require a special process to clean up.

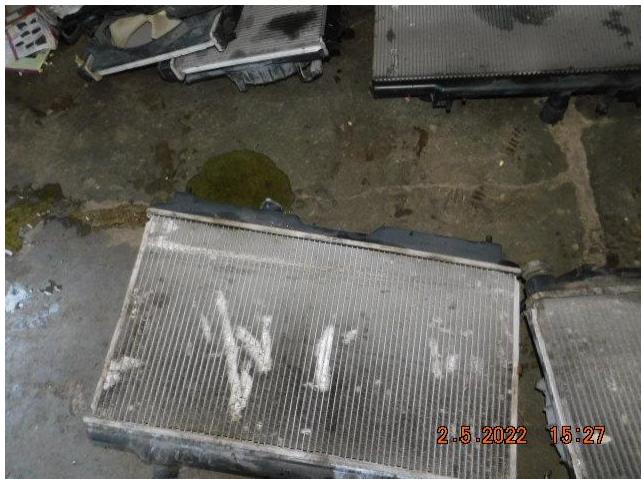
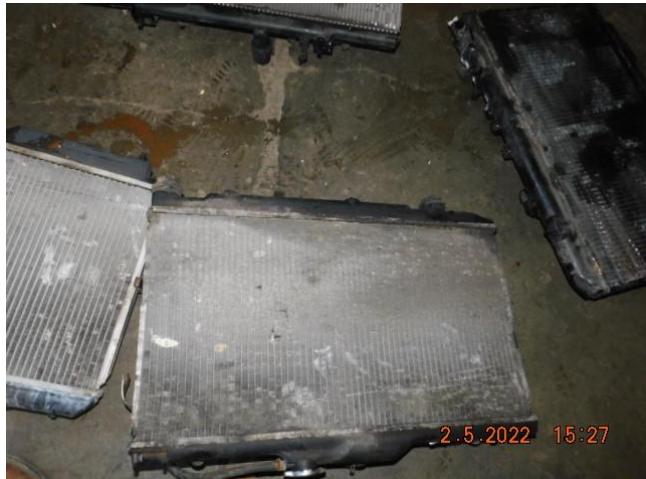
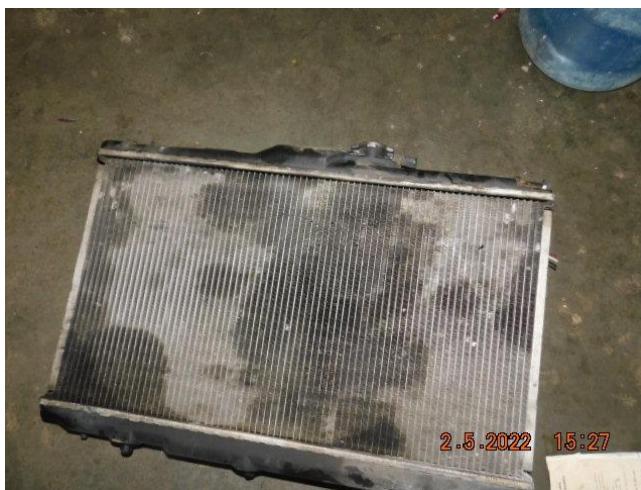
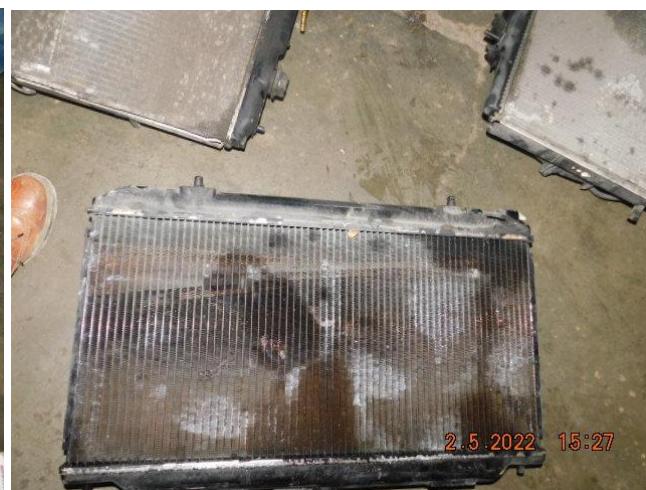
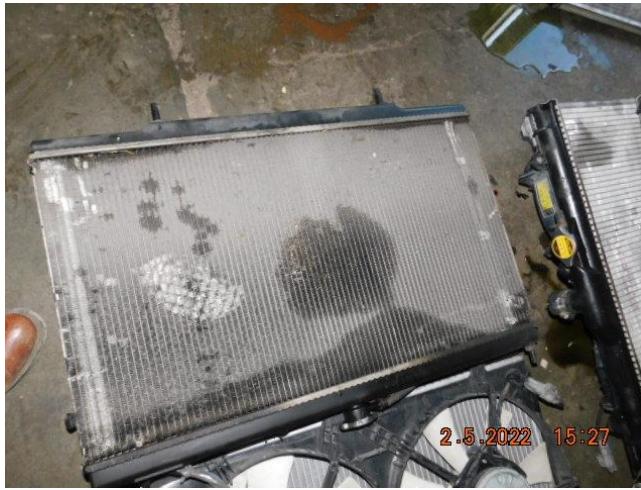
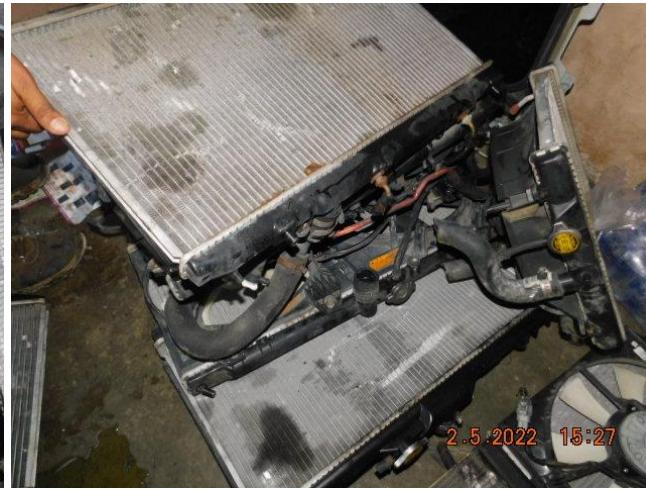
RADIATORS

We also inspected radiators that had their grills with scratches. Please see attached photos.

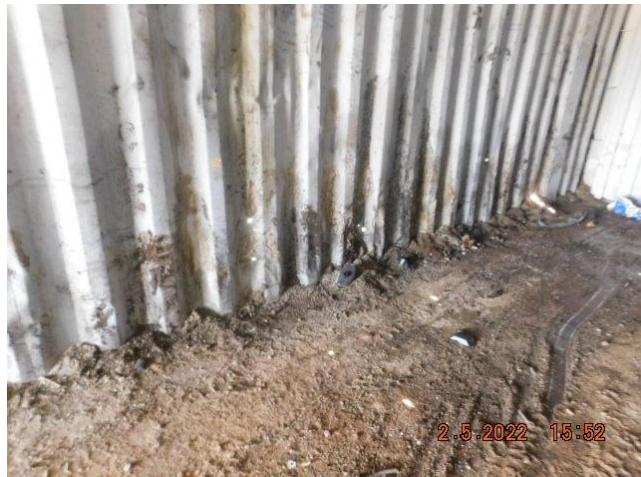
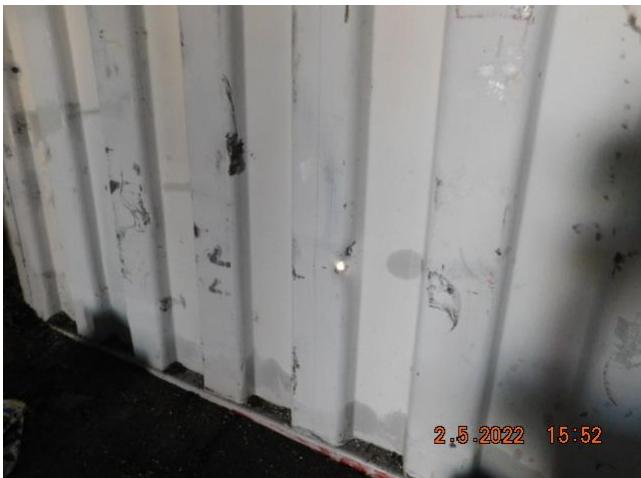
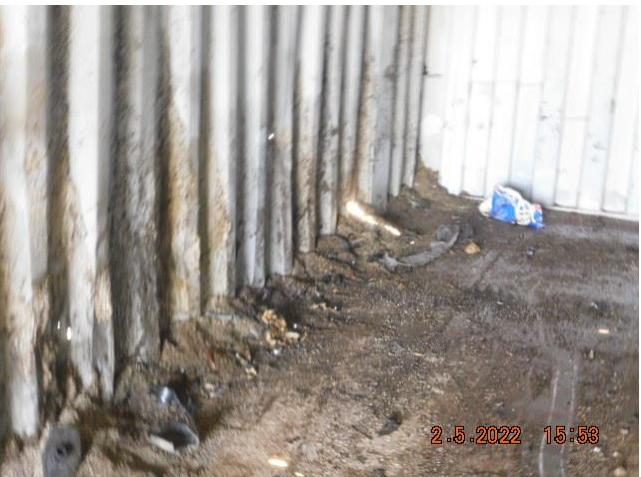
We inspected the container damages from inside, finding the little holes where oil had dripped. We counted 9 holes on the left wall and front wall and another on the roof. (Please see attached photos.
