S U R V E Y - R E P O R T H O-220.007

CONTAINER Nº:	1 X 45' HC Container Nº KOSU 451334-0 ORIGINAL SEAL # UNKNOWN
CARGO:	Junker products; car exteriors, doors, engines, spare parts, radiators, all used, in bulk.
BILL OF LADING Nº:	PEVHON 21540
MARINE TRANSPORT:	PARADERO / 20128
TRANSSHIPPED TO:	N/A
PORT OF LOADING:	MIAMI
PORT OF DISCHARGE:	PUERTO CORTES
PLACE OF DELIVERY:	YONKER RECONCO, CIUDAD COMAYAGUA, HONDURAS
SHIPPER:	NOT AVAILABLE
INVOICE:	NOT AVAILABLE

SURVEY OBJECTIVE: 1- Verify accident site and possible transshipment of container KOSU-451334-0.
2- Verify cargo condition at consignee's warehouse during unloading of the container

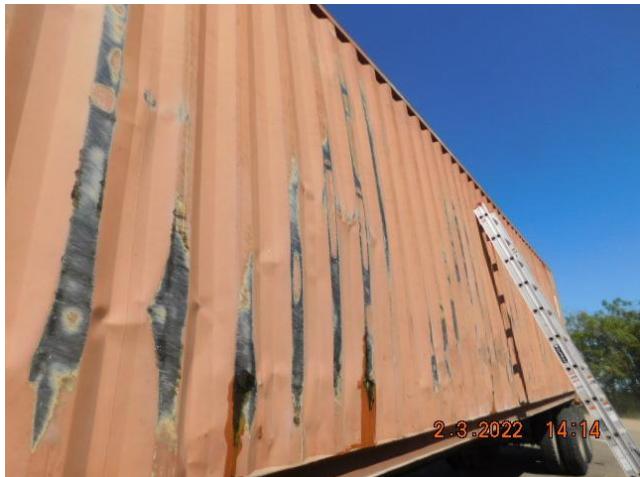
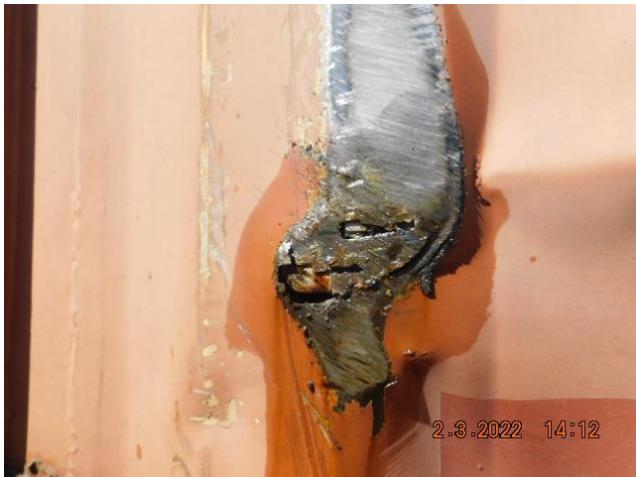
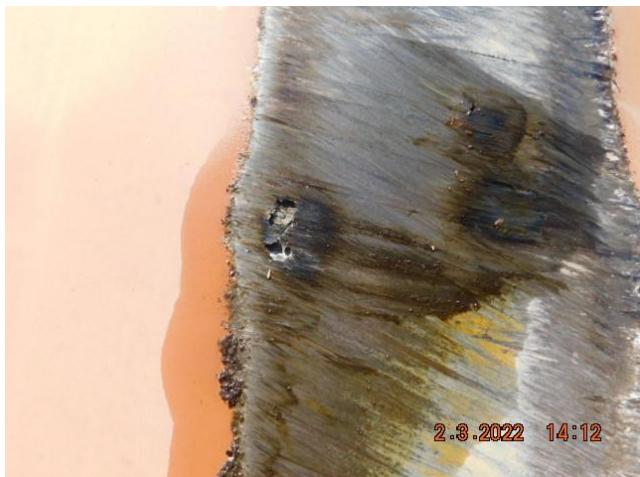
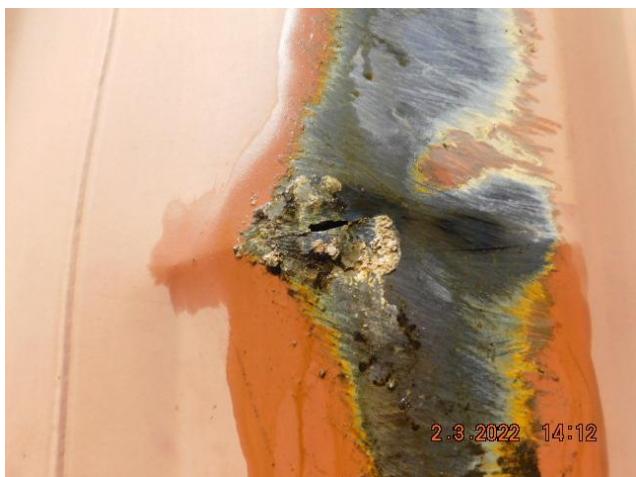
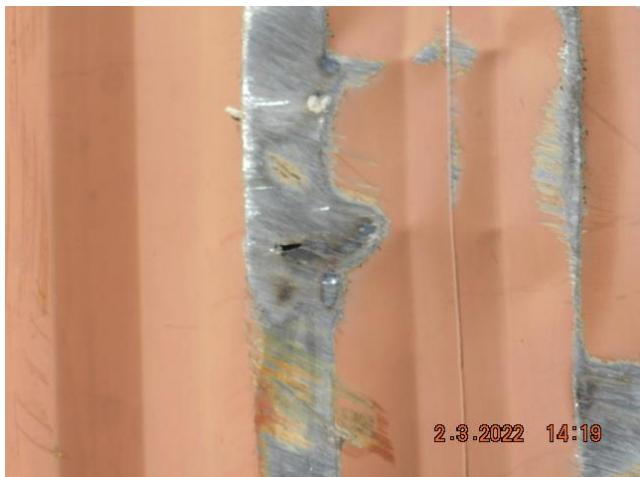
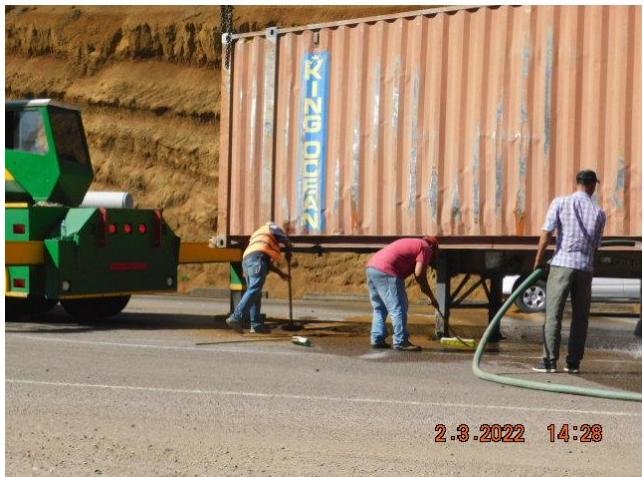
We inspected the container for the damages sustained finding it had the paint surface of the left wall scratched and tiny holes on the wall where oil was already dripping. (Please see attached photos)

We inspected the container damages from inside, finding the little holes where oil had dripped. We counted 9 holes on the left wall and front wall and another on the roof. (Please see attached photos.
