SURVEY REPORT 1482-14

On February 21, 2014, at 15:30 hrs we received a telephone call and E-mail message from Mrs. Jacqueline Mena of EXA Cargo, S.A., requesting a survey inspection regarding container SEGU 902346-0 (Chiquita Logistics) that had suffered an accident on the road to San Pedro Sula (Km126) during inland transit from Comayagua where it had been loaded with fresh Acorn squash with destination Puerto Cortes. The container was said to contain 1370 cases of the squash and after this accident, the cargo was to be transshipped to a new container.

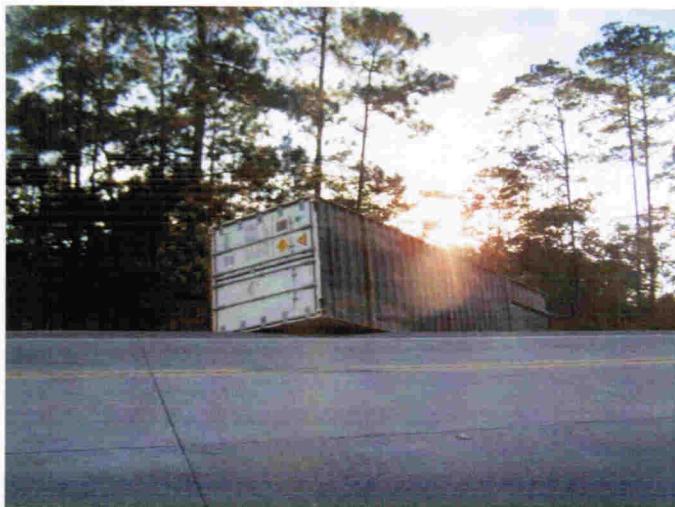
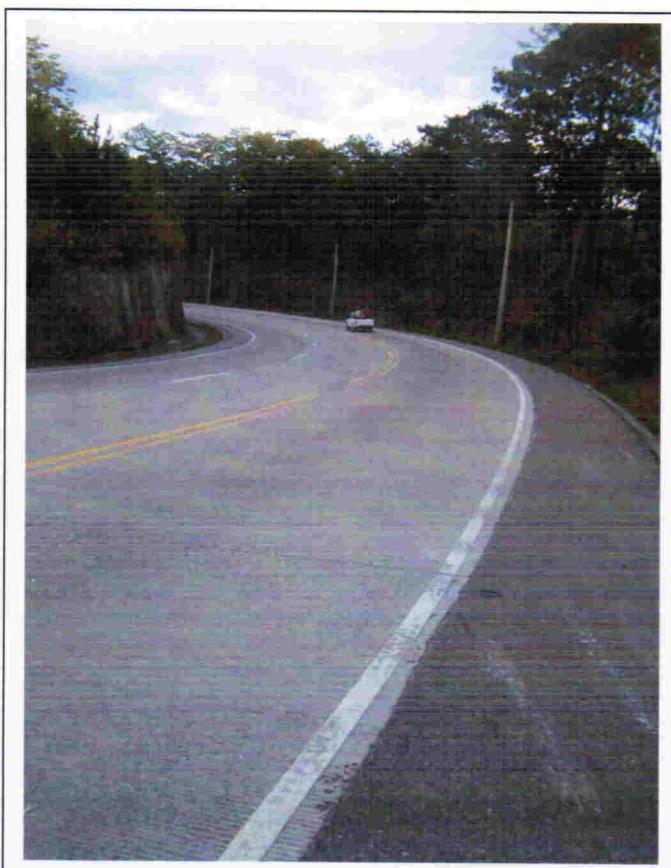
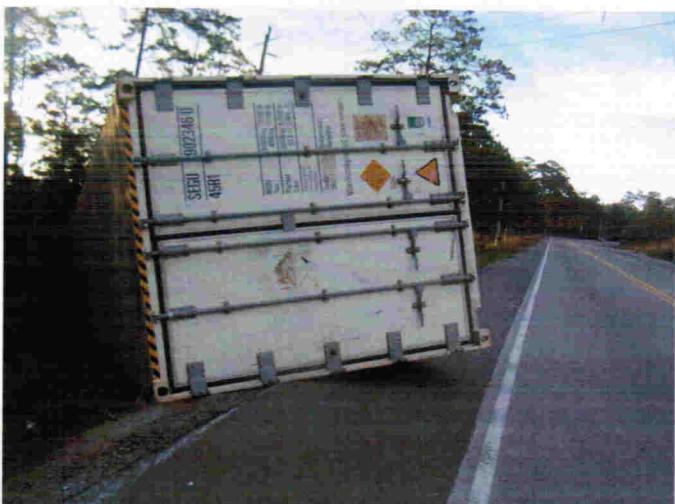
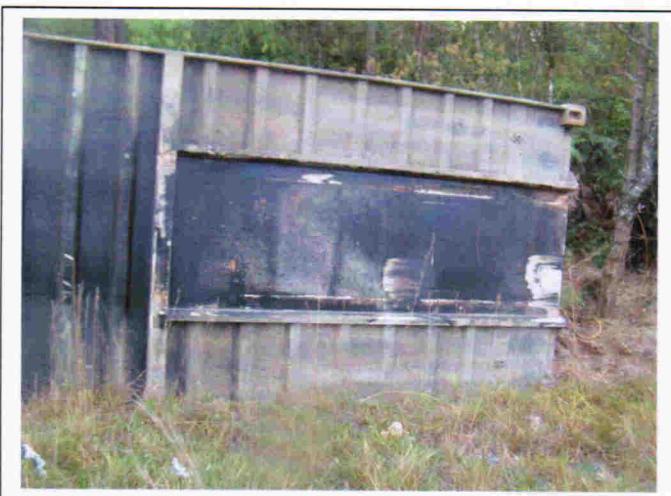
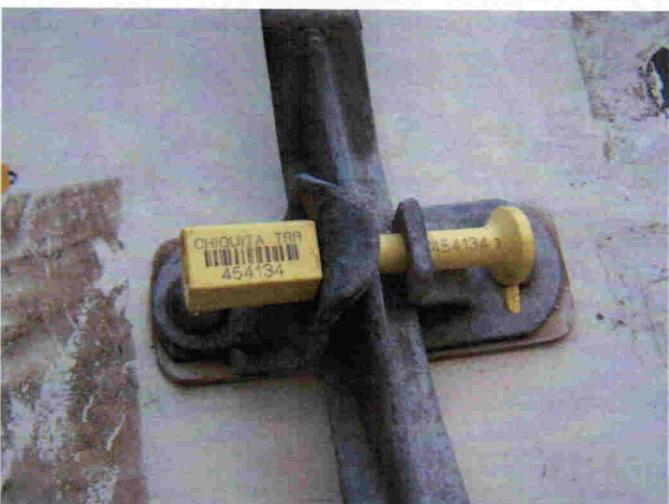
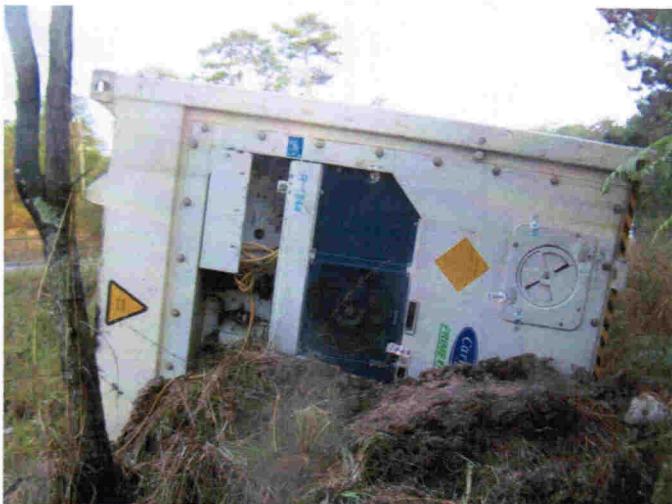
We examined the chassis pins that hold the container locked and found both rear pins broken. The (rear) right pin holder of the chassis was cracked as a result of the pin breaking due to either the weight of the cargo or the pin being worn out and breaking due to failure in the metal resistance. (Please see attached photos).

The accident occurred after the security or locking pins of chassis No.TLXZ 429957 broke letting the container loose which fell to the ground on the side of the highway. Contents lost refrigeration as a result of this accident, for 24 hours and were found above the recommended set point.
